THUNDER MAX

Improving Conductivity of Your Electrical System

Throttle By Wire Instructions - Version 11.09.2011

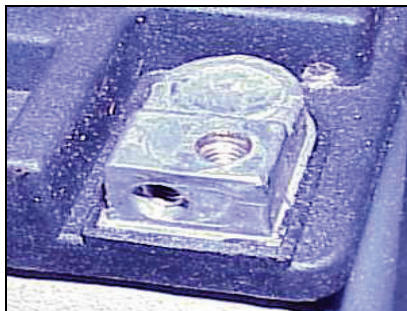
The #1 enemy of your motorcycle's electrical system is a bad or inconsistent GROUND connection which will cause a variety of problems. Corrosion/oxidation is routinely found in the field and can cause problems related to insufficient or interrupted voltage that will affect the performance of your motorcycle. Corrosion has been found on battery cables, fuse connections and relays or completely hidden on the ECM connector. We recommend that all ECM related wiring connectors be inspected and cleaned by swabbing with alcohol and a q-tip, and then applying dielectric grease on the connector before reconnecting to the module. This will improve conductivity and prevent future corrosion or scale from forming on the pins.

- 1) **Remove the ECM Fuse** and disconnect the battery cables; clean and prepare them for re-installation.
- 2) Make sure the battery cables are tight, routed correctly and that any non-original electrical accessories wired on the vehicle are connected to a second, separate mount on the battery, if available (see image below). Temporarily removing or bypassing any non O.E accessory device may be a valid test when troubleshooting.
